# Blow-By Air Vent Odor Fix

by Dan Rounsevell ©2003  
D Rounseve@aol.com

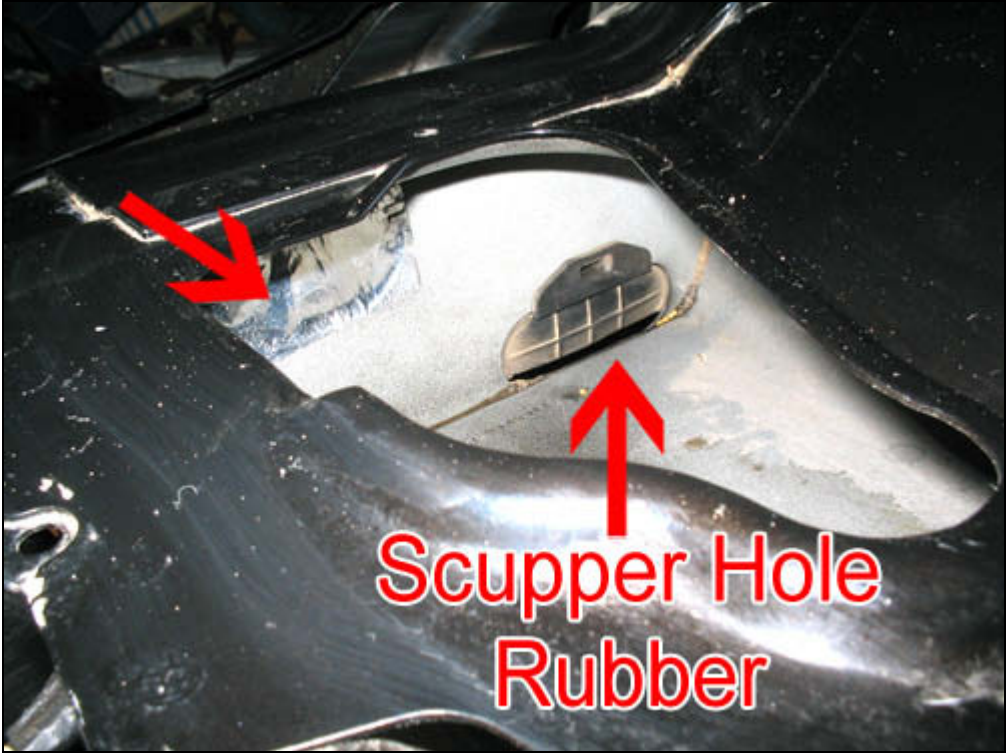
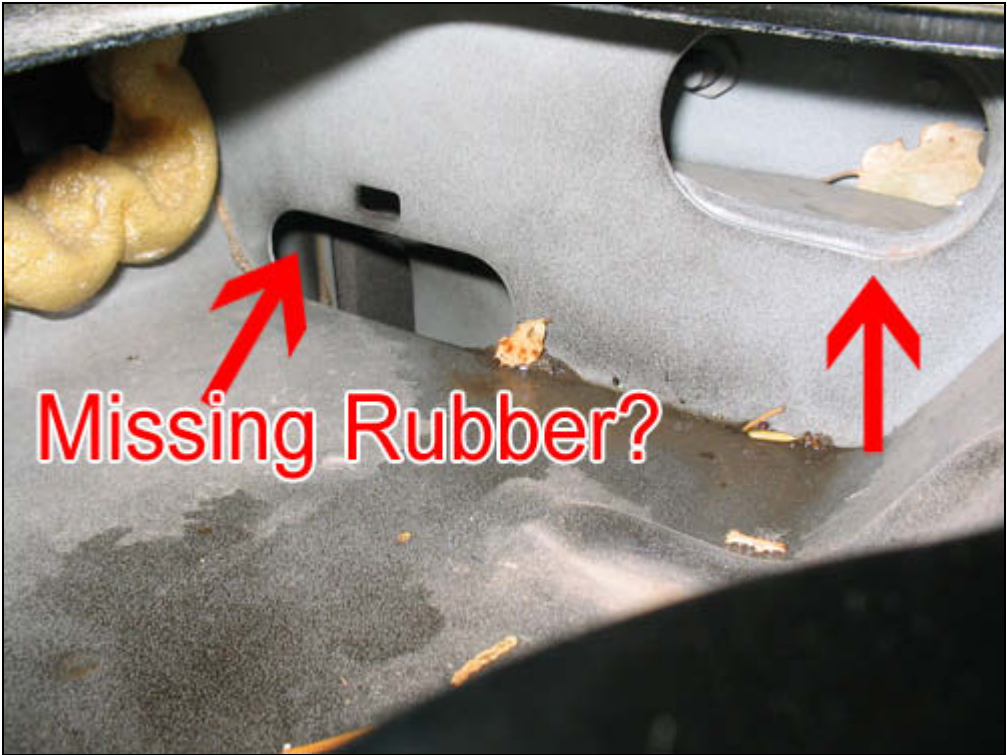
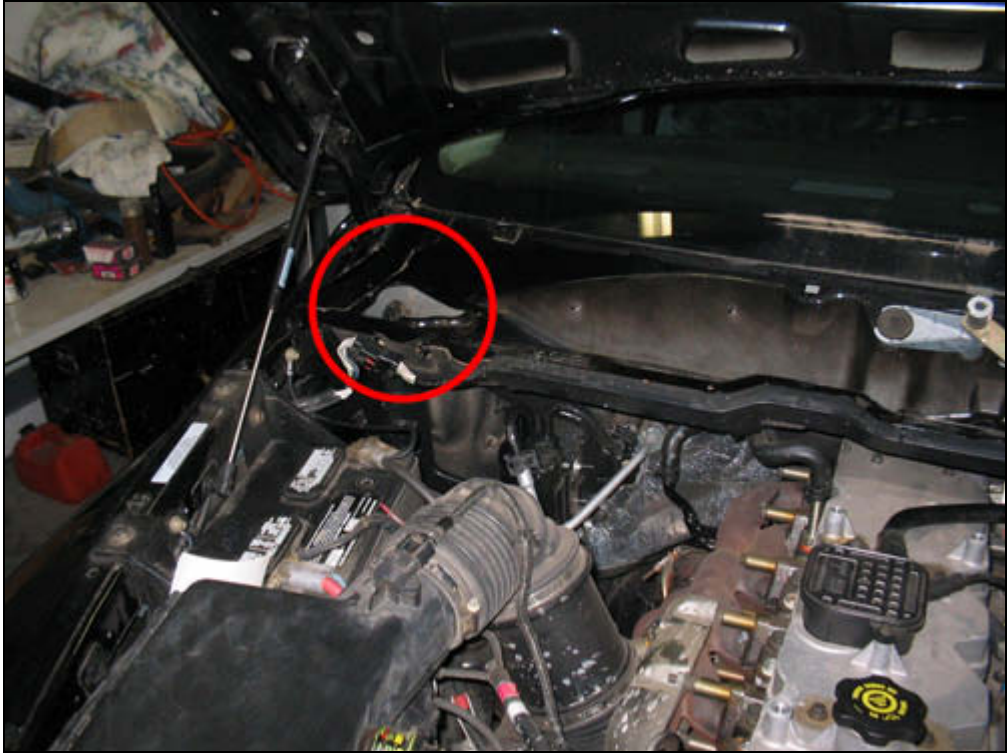
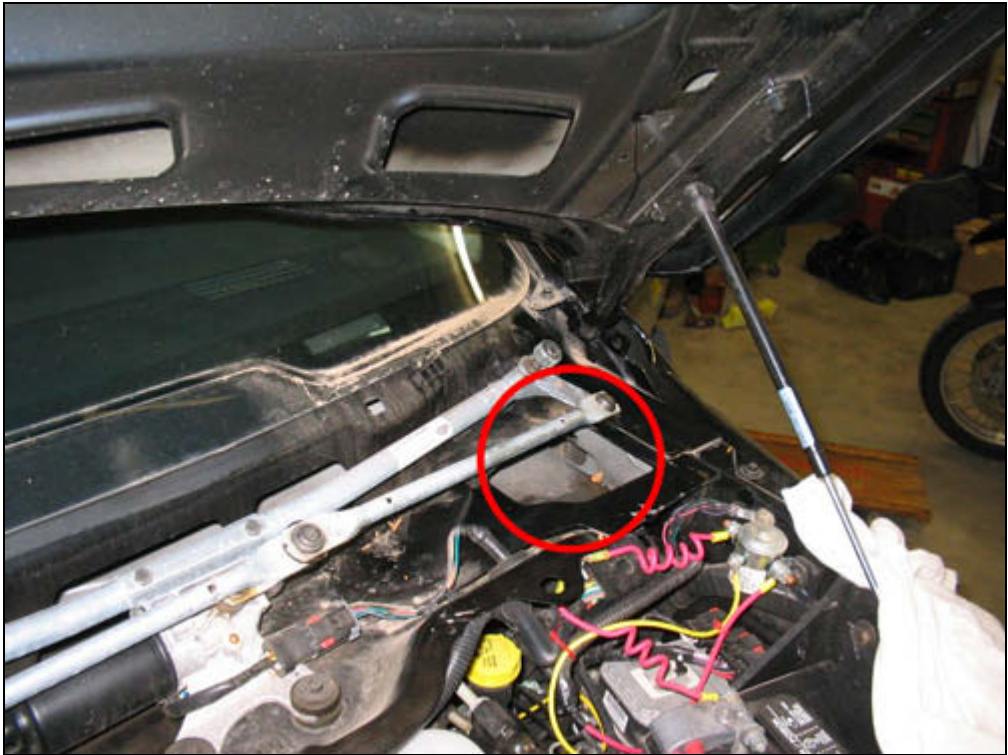
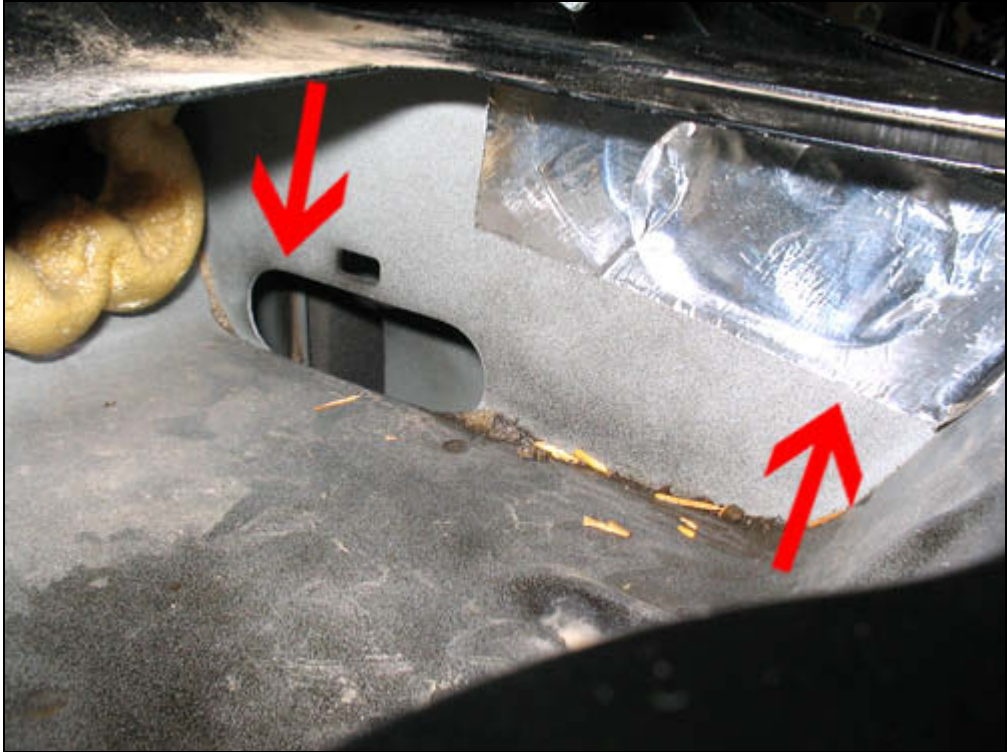
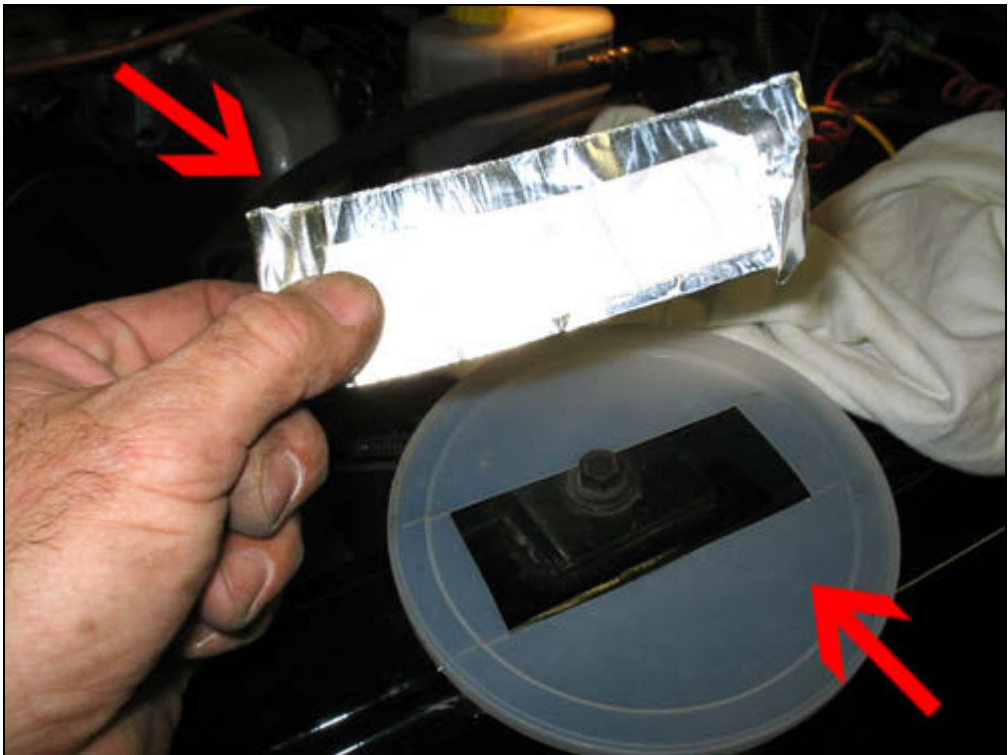
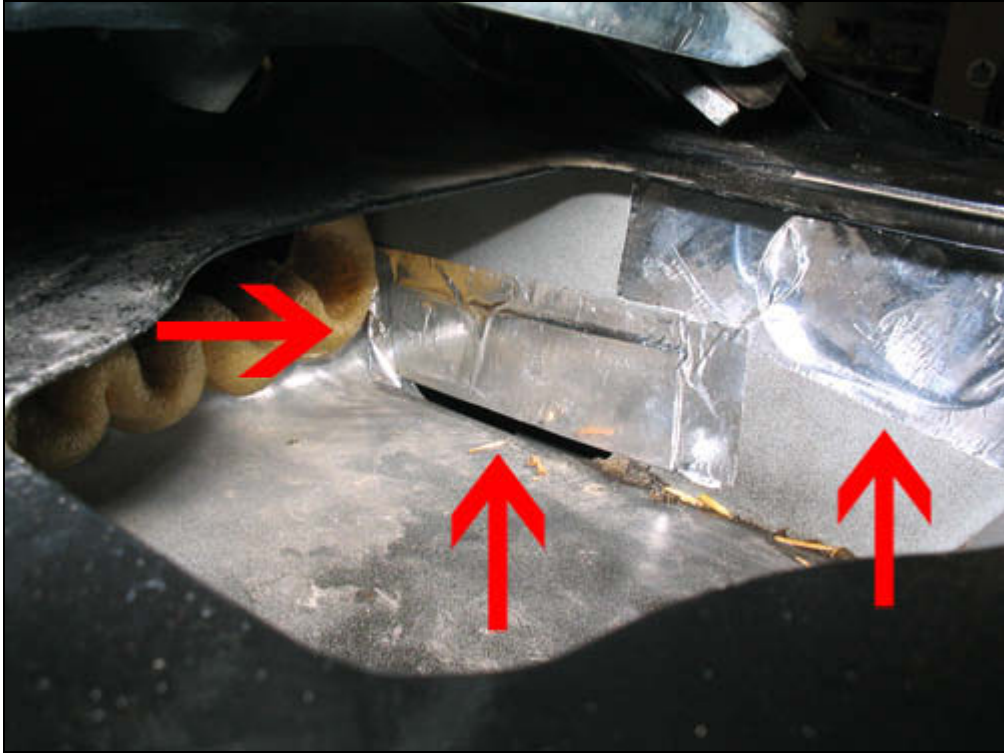
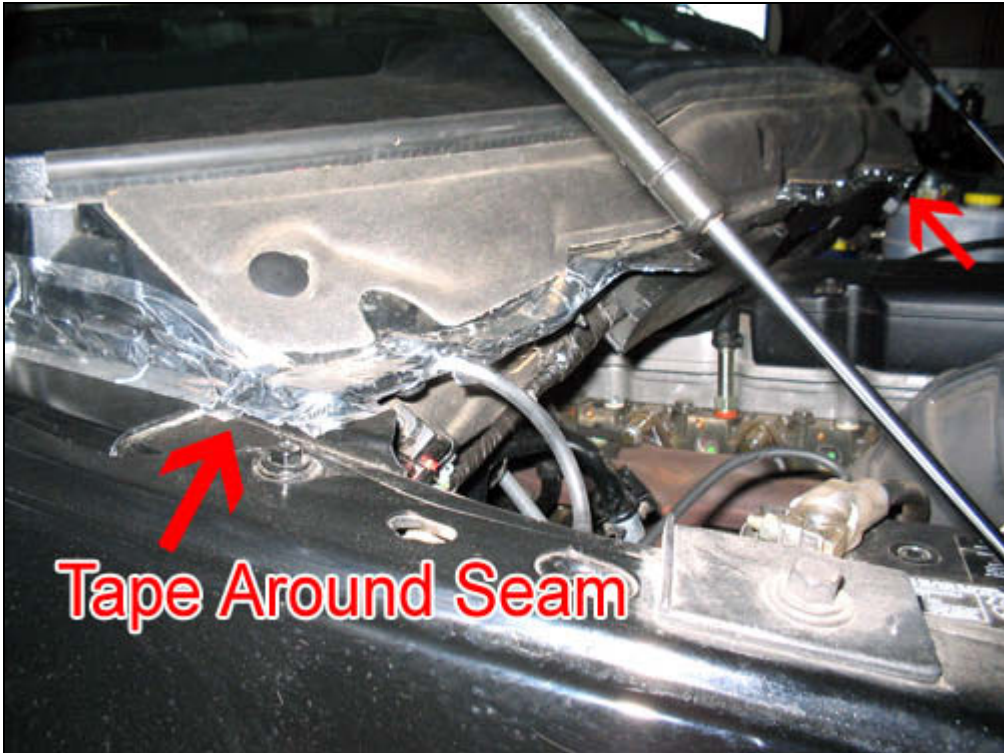
I then removed wiper blades and plastic cowl cover. At the lowest part of the cowl/air box sides are oval shaped cutouts to let water out of box.

One side had a rubber flapper to let water out but seal stuff from entering. The other side was missing. (If it were a deck on a boat it would be called a scupper hole).

Also above and forward of the "Scupper Holes" were cutouts that allows air from engine compartment to pass directly into the air box.

I sealed the holes with aluminum high temp duct tape and cutout plastic coffee can lids. I left a small gap for water to drain and sealed around cowl plastic/metal seam with the tape.

I repeated the air freshener test and wife gave it the thumbs up!
